This addendum links from the main skeg repair article on UKSKGB at http://www.ukseakayakguidebook.co.uk/skeg_repair/art_skeg_repair.htm and was provided by Tom Fuller.

Just done the skegs on a couple of plastic Capellas, I think they are 2004 models.

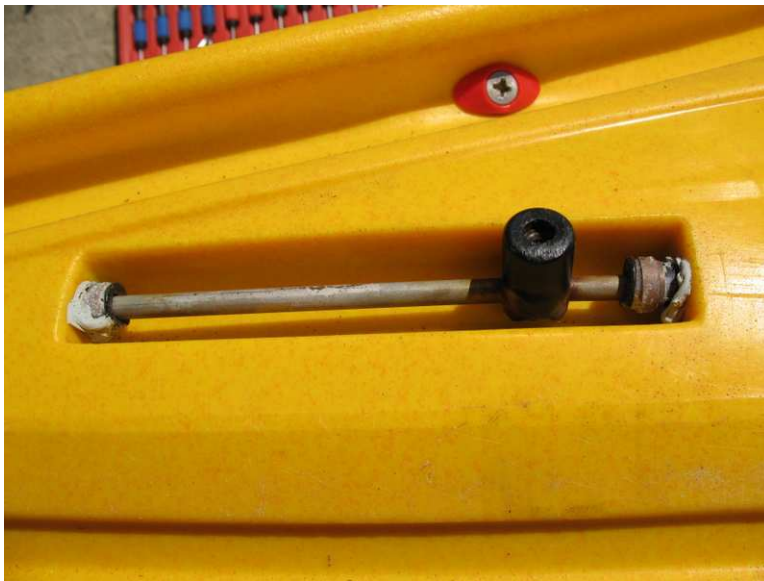
Firstly, the skeg control is a wee plastic handle on a tubular slider. The slider goes through a couple of skin fittings, and the cable goes through the tube, where it is secured with a screw that goes through the plastic handle and into the tube.

Removing the screw (philips head) allows the cable to be withdrawn. That is, if the head of the screw does not immediately shear out leaving a really tricky job to drill out 15mm of screw without destroying the plastic toggle! I opted to drill it all out a bit larger, then fill the void with araldite, and then drill out the araldite to the right size for a new screw....what a carry on!

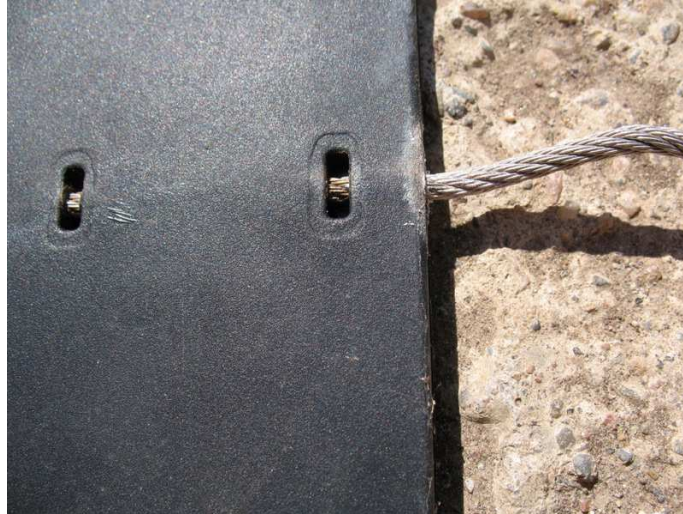
Next, the cable is attached into the skeg differently.

As you can see, the cable has been moulded into the plastic. I thought this might be game over, but I put the cable into a vice and started twisting - as if to unscrew the cable from the skeg. Fortunately they both came out like this. I'd recommend snugging the skeg right up against the vice before you start tightening - when I didn't do this the cable started to crack and fray and I thought it might just twist off.

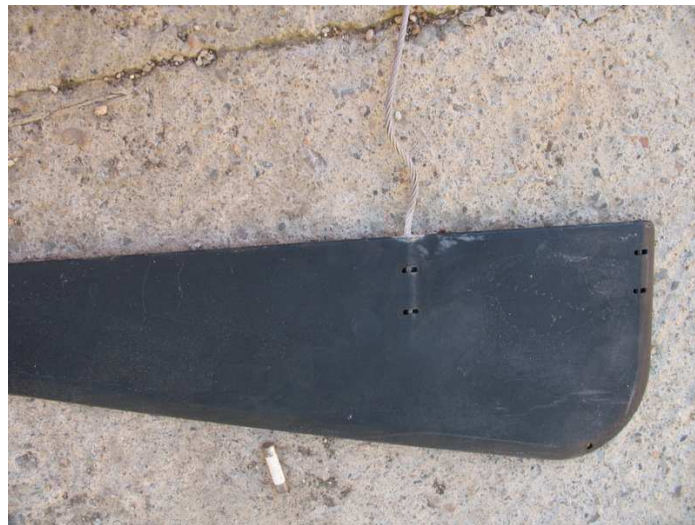
I then cleaned out the hole with a wee drill. As you can see there are a couple of slots where you can see the cable pass through, there are two the other side, which are aligned differently. I cleaned these out with the drill too as they are a good place to get lots of glue in.

Then as with yours I got plenty glue into all the holes, and worked the cable through it a few times to get it all well coated, then left to harden.
